National Dam Inspection Program.

Strack's Dam (NDI Number PA-00596,  
DER Number 38-20), Delaware River Basin,  
Lebanon County, Pennsylvania. Phase I  
Inspection Report.

PHASE I REPORT  
NATIONAL DAM INSPECTION PROGRAM  
BRIEF ASSESSMENT OF GENERAL CONDITIONS  
AND RECOMMENDATIONS

Name of Dam: STRACK'S DAM, NDI NO. PA-00596  
State & State No: PENNSYLVANIA, 38-20  
County: LEBANON  
Stream: TRIBUTARY TO TULPEHOCKEN CREEK  
Date of Inspection: April 6, 1979

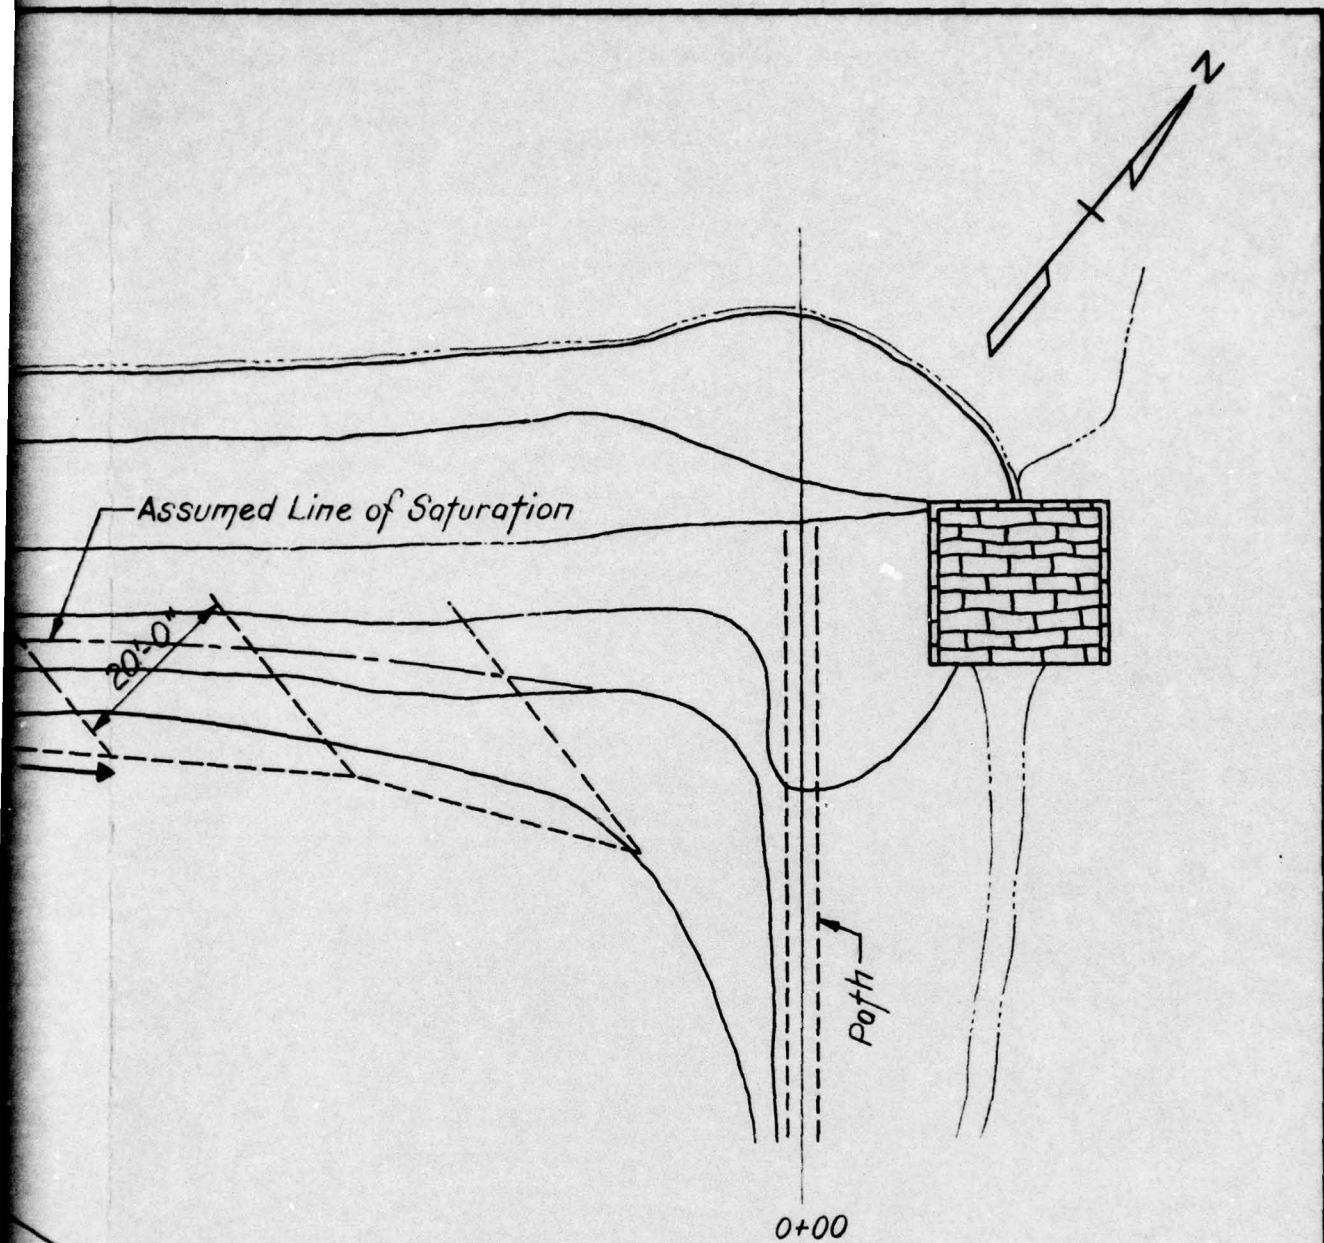
In 1933, an effort was made to reduce leakage by drilling holes in the embankment at leakage points and to fill these holes with tamped clay. Only three holes were drilled. In 1938, a lateral drainage system was installed in the downstream embankment (Plate V, Appendix F).

The downstream slope has a dense growth of brush and trees, with trees up to 18 inches in diameter. The brush prevents close observation of the slope and sloughage or slippage areas were not noticed. The slope is, however, saturated and soft over most of its height. At the toe and downstream of the toe, the ground is totally saturated, marshy and soft. The soft condition of the slope has caused some trees to be uprooted and it is feared that additional uprooting of trees could occur. The subsurface drainage system installed on the downstream slope and in the toe is not functioning properly.

*Traced from Drainage System for Embankment  
Strack Dam, by American Water Works  
Construction Company Engineers and  
Contractors Dated 3/17/38.*
